Ultrasonic Inspection of Titan IV Stage I Baffles

1 March 1996

J. P. NOKES
Mechanics and Materials Technology Center
Technology Operations

6. AUTHOR(S) J. P. Nokes				
7. PERFORMING ORGANIZATION NAME(S) AND ADDRESS(ES) The Aerospace Corporation Technology Operations El Segundo, CA 90245-4691			8. PERFORMING ORGANIZATION REPORT NUMBER TR-95(5530)-3

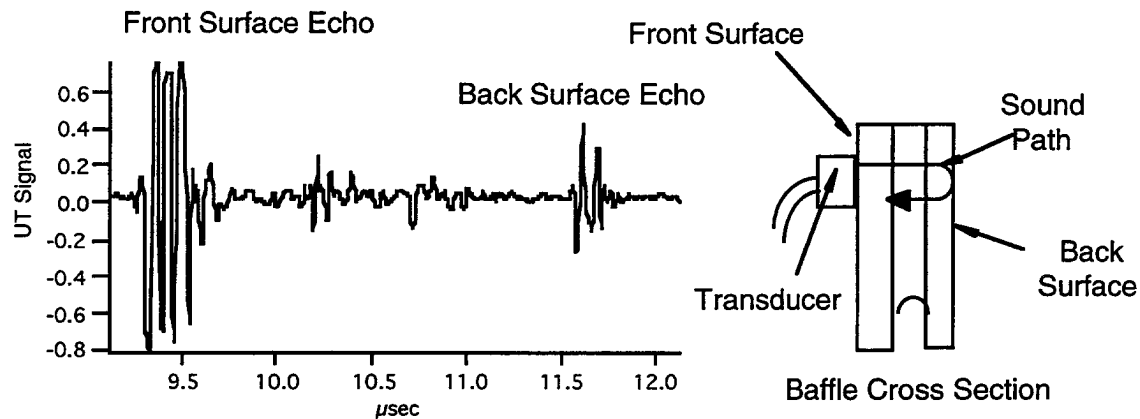
Figure 4. Ultrasonic signal from a baffle rib indicating a good contact between both face plates and the rib.

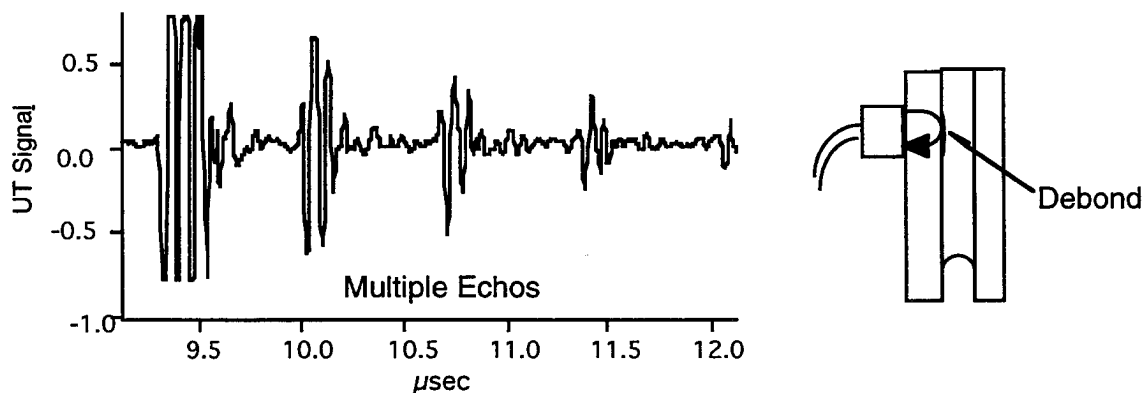
The signal displayed in Figure 5 is typical of the return that would be expected from a front-faceplate/baffle debond. In this case, the ultrasonic pulse travels a path that is equivalent to twice the thickness of the faceplate. As a result, the waveform in Figure 5 is also characteristic of the signal obtained from a position on the baffle between ribs since the normal faceplate/air interface is indistinguishable from that of the faceplate/baffle with a debond.

Figure 5. Ultrasonic signal showing the multiple reflections typical in the front surface debond.

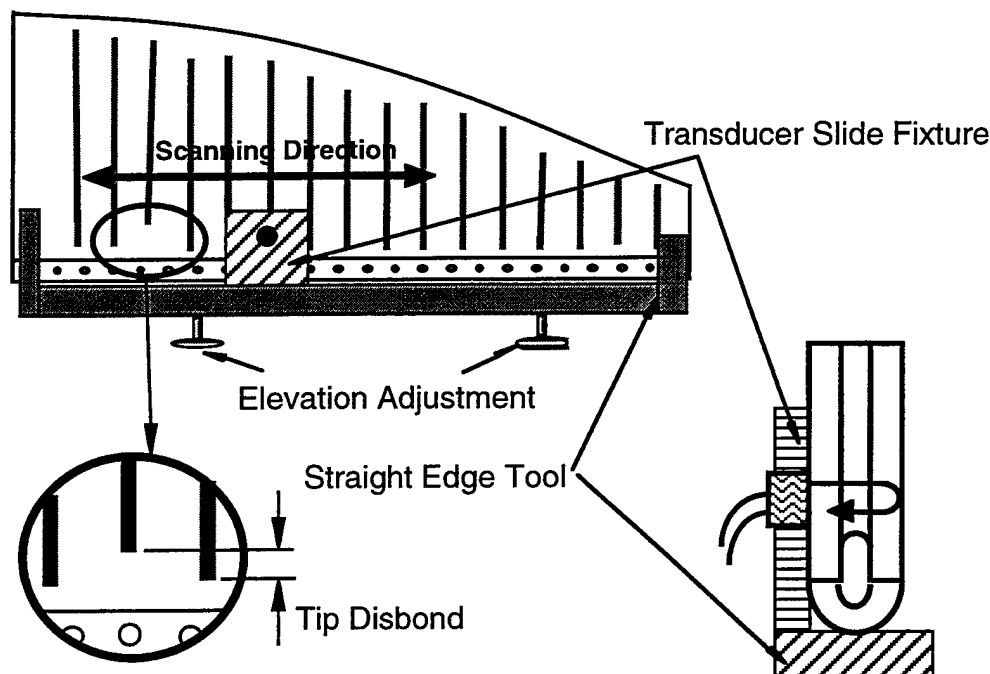
While investigating simulated baffle debonds, difficulties were noted in evaluating debonds at the rib tips. Over the majority of the baffle area, debonds in an individual rib could be located and sized by detecting the edges of the debond area. However, at the rib tips, it was difficult to determine for a particular rib whether the displayed signal indicated an actual debond or simply that the transducer had moved past the end of the rib. The difficulty was exacerbated when an inspection was made in

the combustion chamber without the visual cues found on the bench top. To meet the stated (< 0.10 -in.) resolution requirements, a different approach was taken for inspecting the rib tips. Instead of evaluating each rib individually, a horizontal scan was implemented that compared an individual rib tip to the other 15 ribs, as shown in Figure 6. A Teflon™ tool was used to position the transducer at the desired elevation on the baffle. The fixture allowed for the centerline position of the transducer to be adjusted to account for variations in the hardware. Using this scanning approach and the focused transducer, rib debonds on the order of 0.035 in. could be detected.

Figure 6. Ultrasonic Inspection near the rib tips.
